Report: Chilit/RF08156

**A fire resistance test performed on
two single leaf single acting doorsets**

**Test conducted in accordance with BS
476: Part 22: 1987**

**Prepared for: Corinthian Industries (Asia) Sdn Bhd
PT 29823 Jalan Genting off 4th Mile
Jalan Kapar
42100 Rantau Panjang
Klang
Selangor
Malaysia**

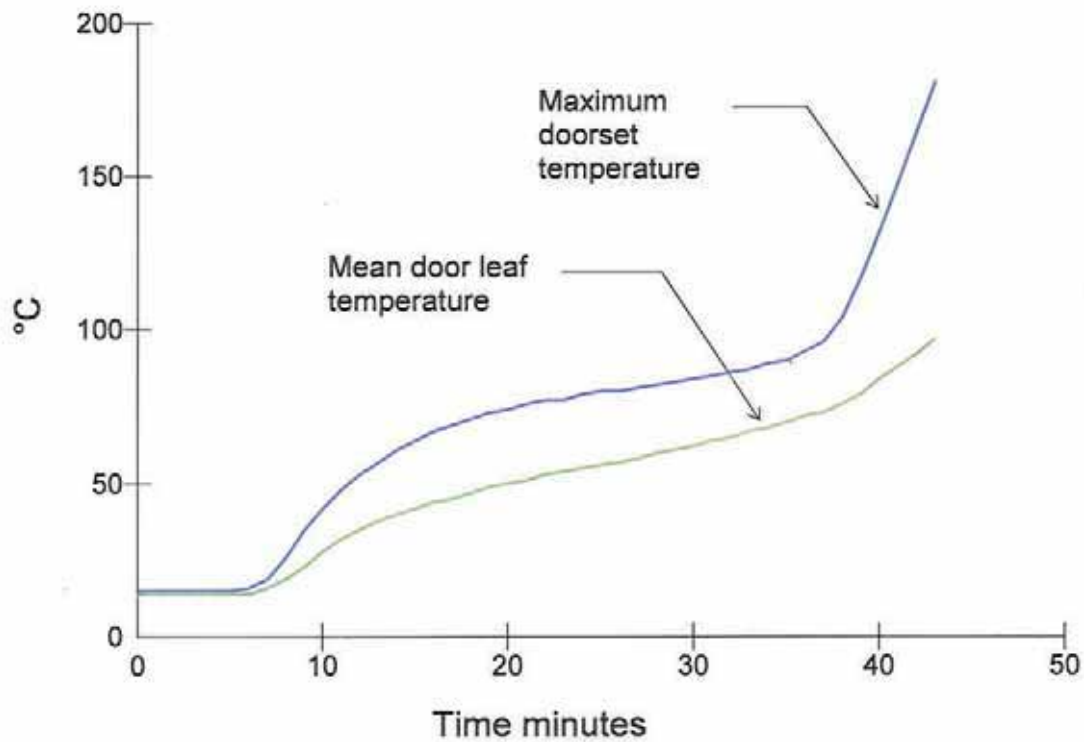
Doorset A

10.30	Doorset A, there is discolouration at the top hanging corner and down the hanging edge of the leaf approximately 150mm long.
14.49	Doorset A, there is discolouration at the top closing corner of the leaf.

35.15	Doorset A, a cotton pad integrity test was performed approximately 100mm down from the top hanging corner of the leaf, no failure.
36.35	Doorset B, there is a glow visible in the groove where the top rail meets the left stile. Doorset A, there is discolouration and smoke issuing at the middle hinge position.

40.20	Doorset B, a cotton pad integrity test was performed where the left stile meets the bottom of the top rail, no failure.
43.23	Doorset A, there is intermittent flaming at the middle hinge position and the top hanging corner of the leaf.

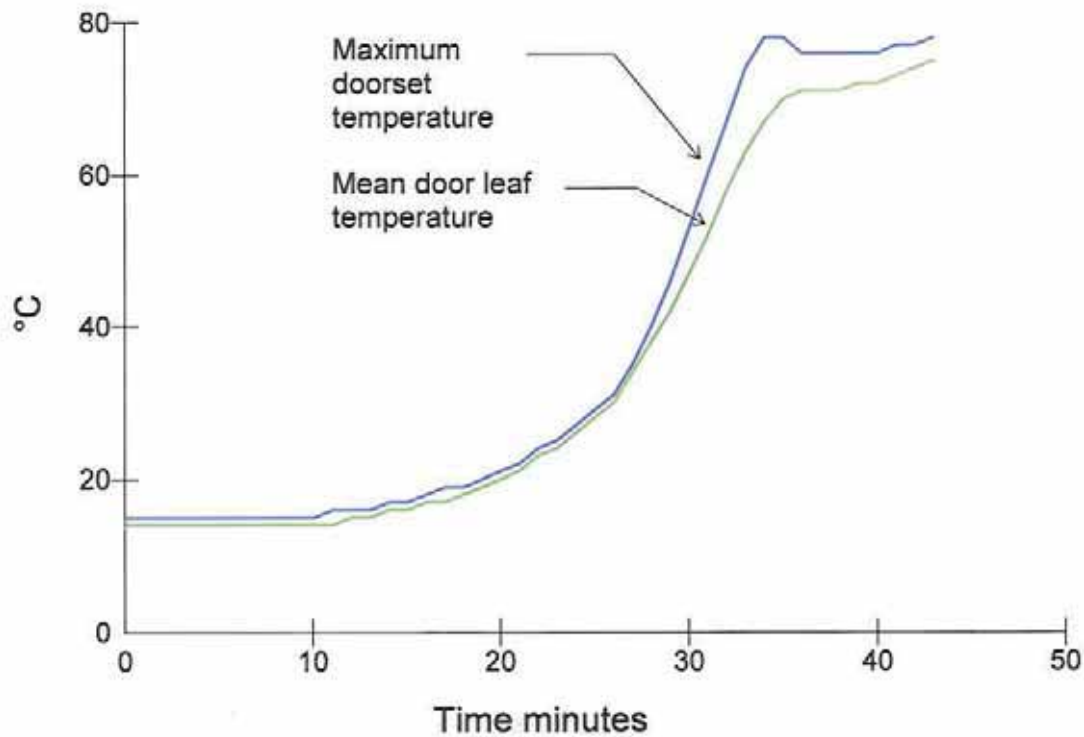
Doorset B

Time (minutes)	Comments
00.00	Test started.
08.04	Doorset B, there is discolouration at the top hanging corner and down the hanging edge of the leaf approximately 250mm long.

19.14	Doorset B, there is discolouration and smoke issuing from across the head of the leaf.
30.10	Both doorsets, there is a glow visible approximately 100mm down from the top hanging corners of the leaves.

31.25	Doorset B, a cotton pad integrity test was performed approximately 100mm down from the top hanging corner of the leaf, no failure.
33.38	Doorset B, there is smoke issuing from the top left of the leaf where the top rail meets the right stile.

43.40	Doorset B, there is continuous flaming from across the head of the leaf originating from the groove thereby constituting integrity failure .
44.00	Test terminated.
