test report

Ad-Hoc Fire resistance test utilising the general principles of BS 476: Part 20: 1987 on three specimens of linear gap seals and three specimens of penetration seals mounted within a plasterboard wall construction

151680

Date: 18th April 2006

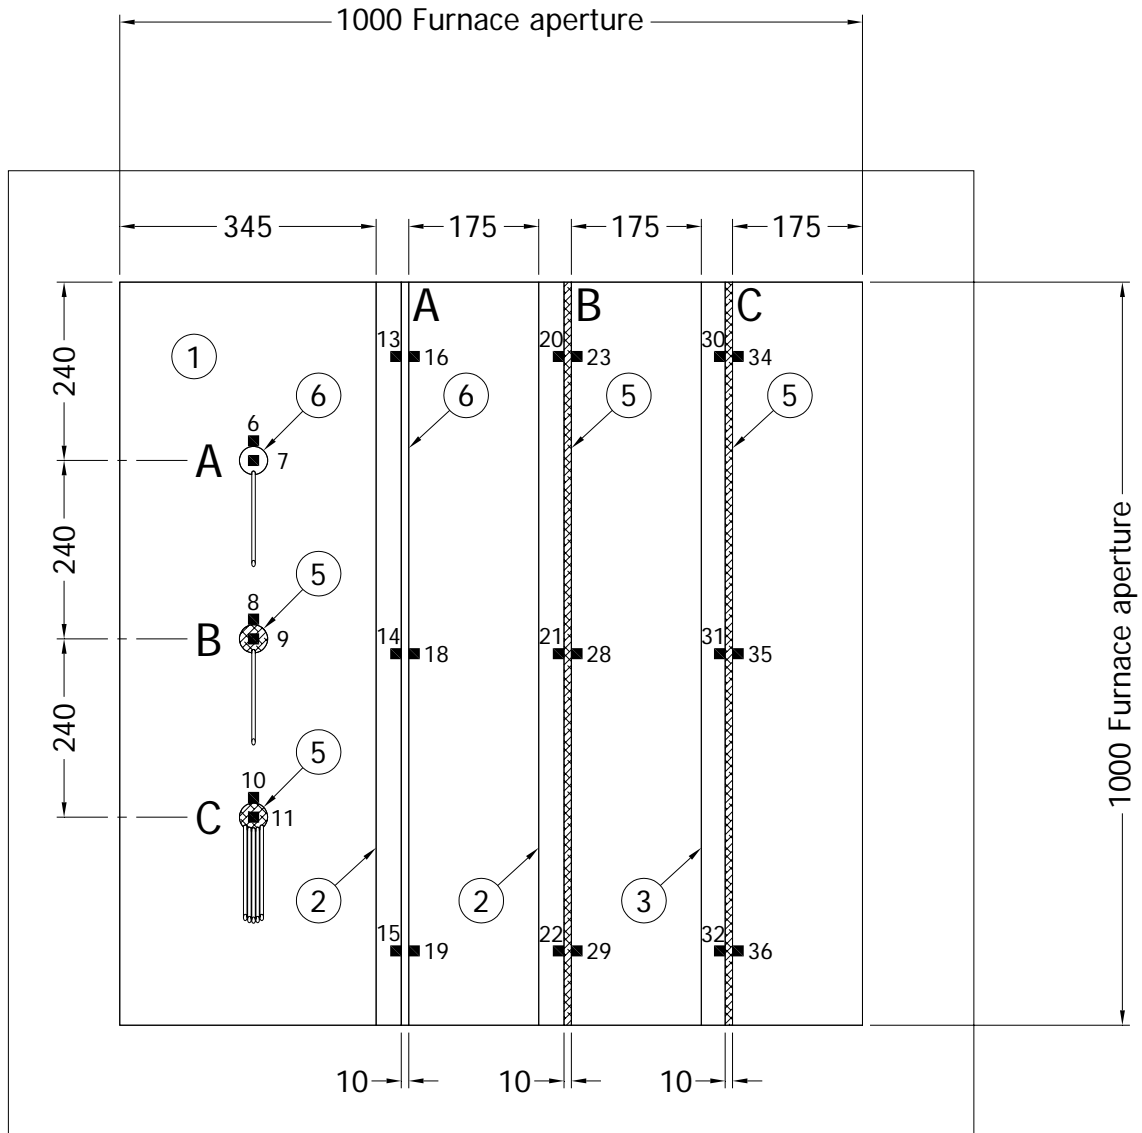
Figure 1- General Elevation of Test Assembly

■ Positions of thermocouples

Penetration Seals	<p>At two positions, one on the surface of sealant and one on the surface of the plasterboard, 25 mm away from the edge of each seal.</p> <p>The locations and reference numbers of the various unexposed surface thermocouples are shown in Figure 1.</p>
Roving Thermocouple	A roving thermocouple was available to measure temperatures on the unexposed surface of the specimens at any position, which might appear to be hotter than the temperatures indicated by the fixed thermocouples.
Integrity Criteria	Cotton pads and gap gauges were available to evaluate the integrity of the specimens.
Furnace Pressure	After the first five minutes of testing, the furnace pressure was controlled to maintain a slightly positive pressure relative to the pressure of the laboratory. The furnace atmospheric pressure was measured and controlled at a mid-height of the wall assembly, the differential pressure was calculated to be 15 Pa +/- 2 Pa.

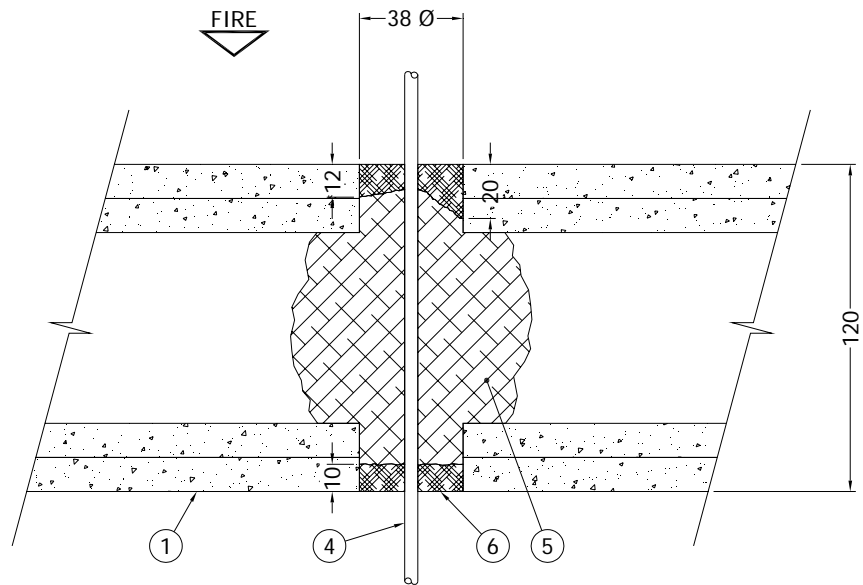
Figure 2 – Details of Specimens

HORIZONTAL SECTION THROUGH PENETRATION A

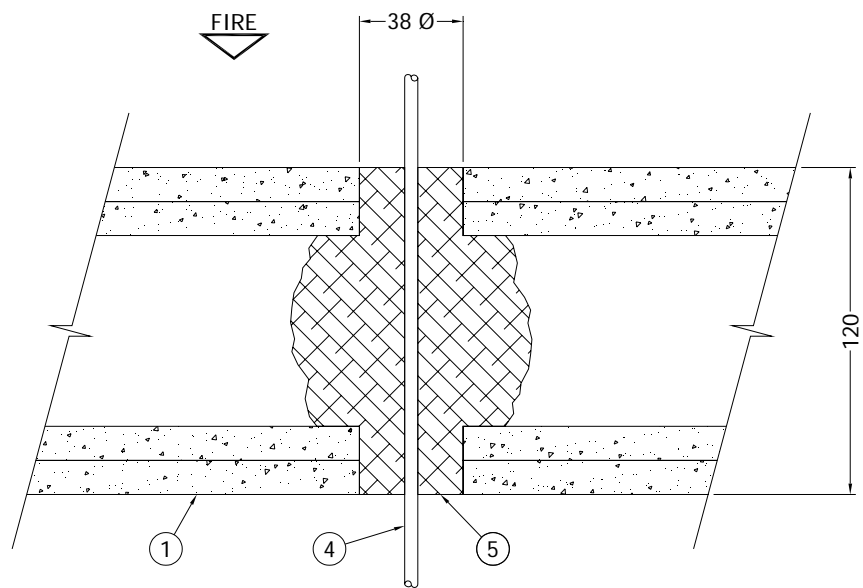
HORIZONTAL SECTION THROUGH PENETRATION B

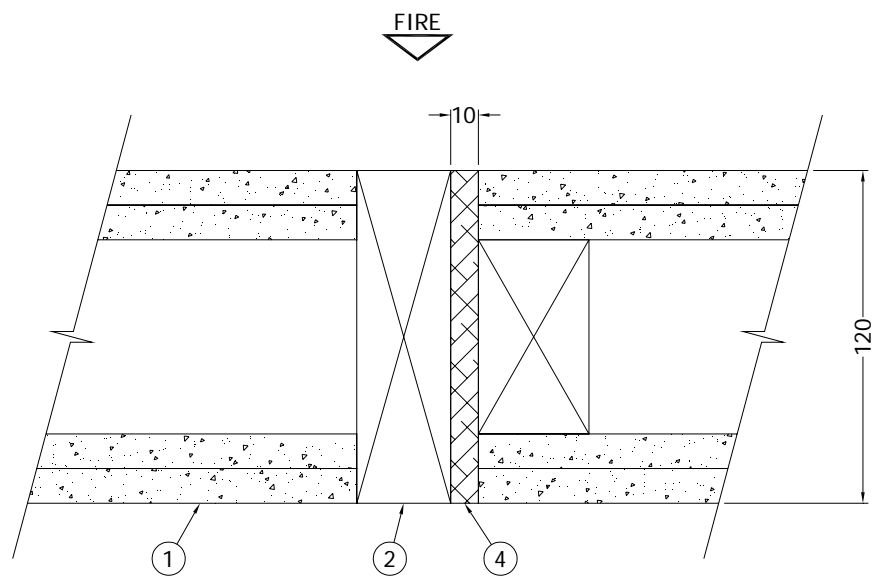
Figure 4 – Details of Specimens

HORIZONTAL SECTION
THROUGH LINEAR GAP B

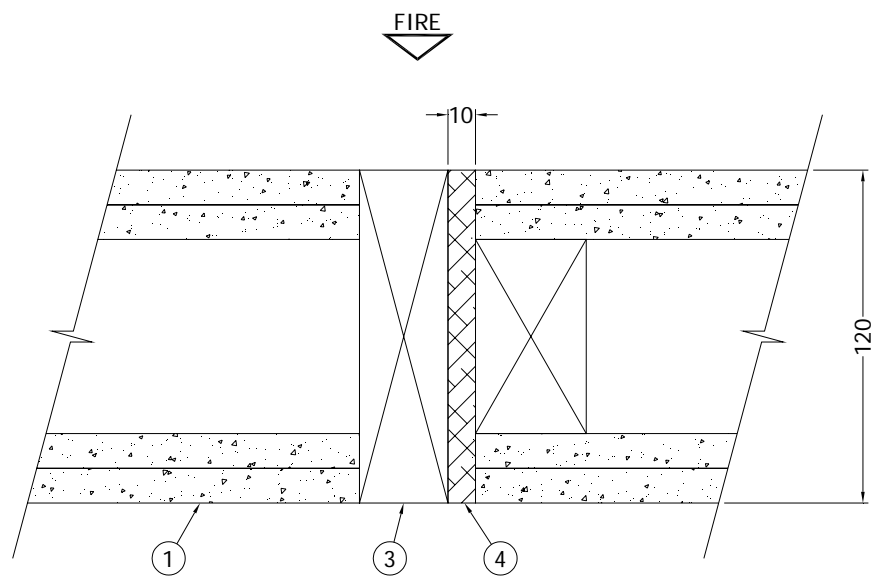
HORIZONTAL SECTION
THROUGH LINEAR GAP C

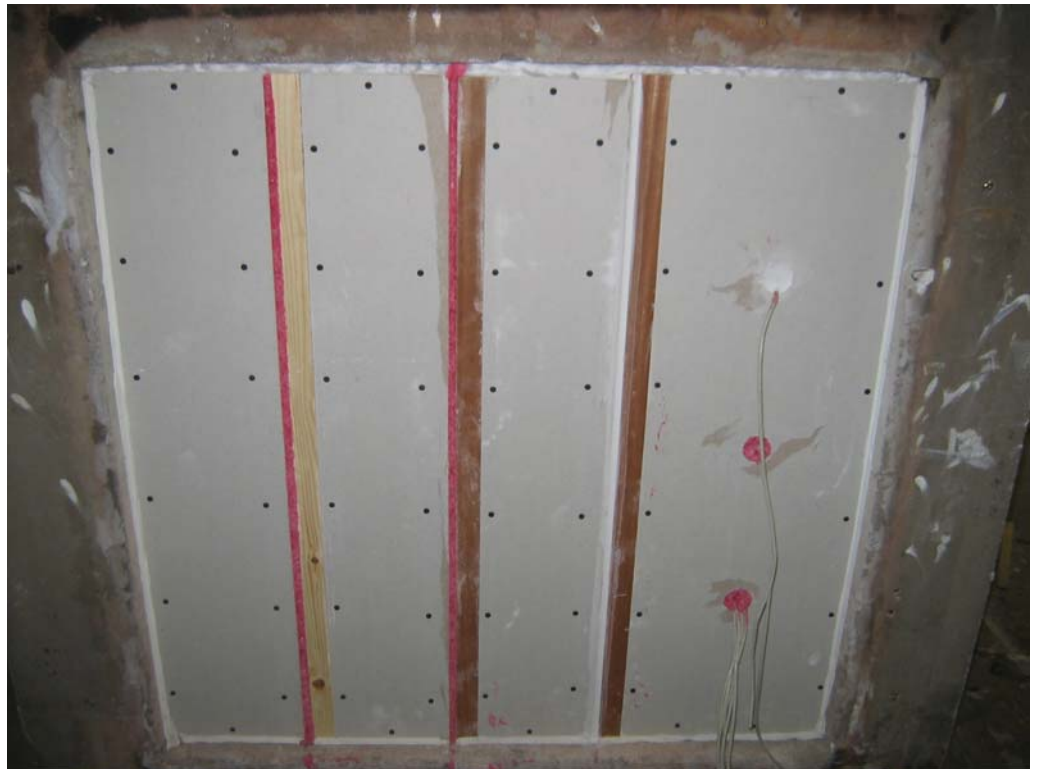
The exposed face of the construction prior to testing

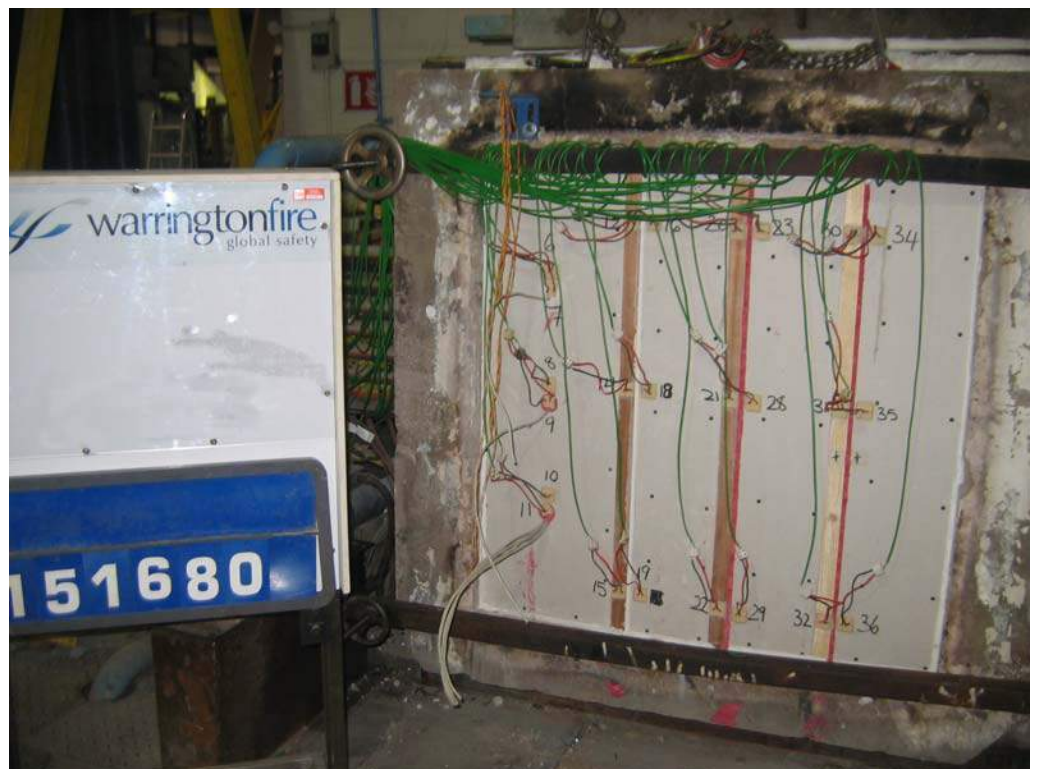
The unexposed face of the construction prior to testing

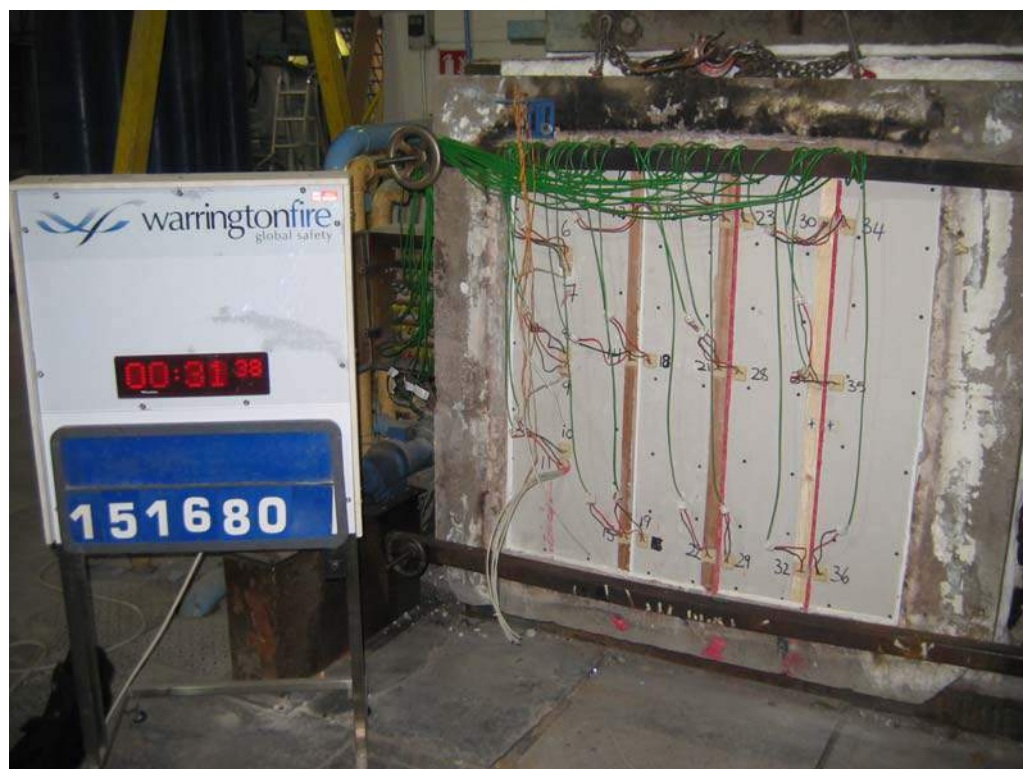
The unexposed face of the construction after 31 minutes of testing

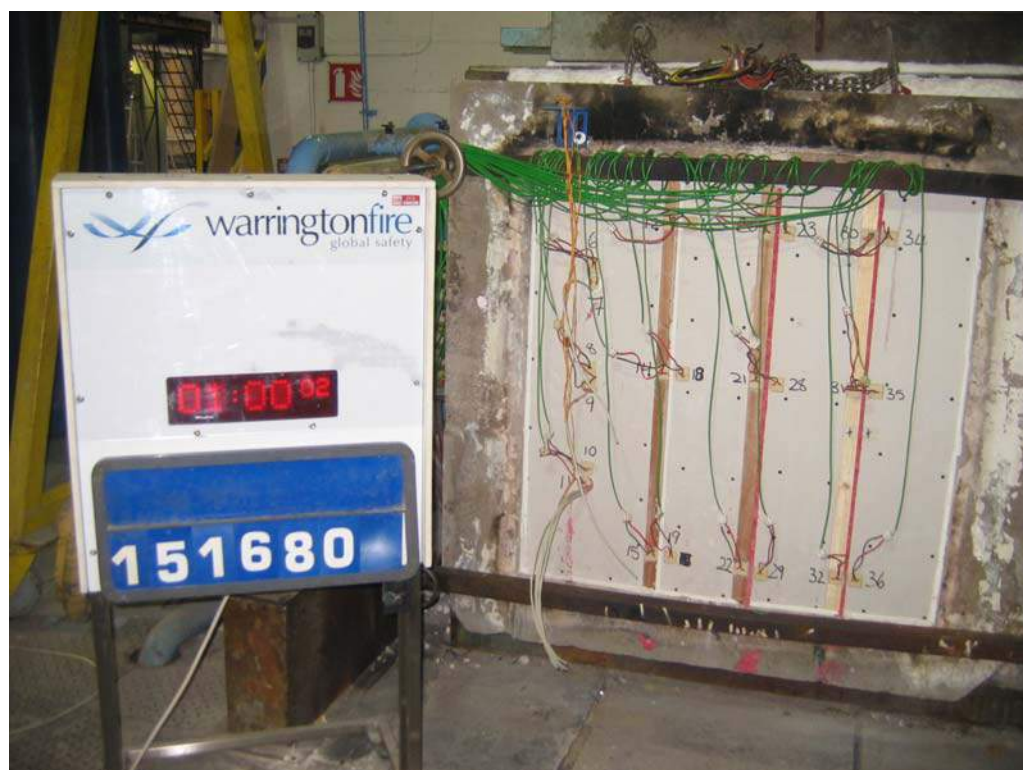
The unexposed face of the construction after 60 minutes of testing

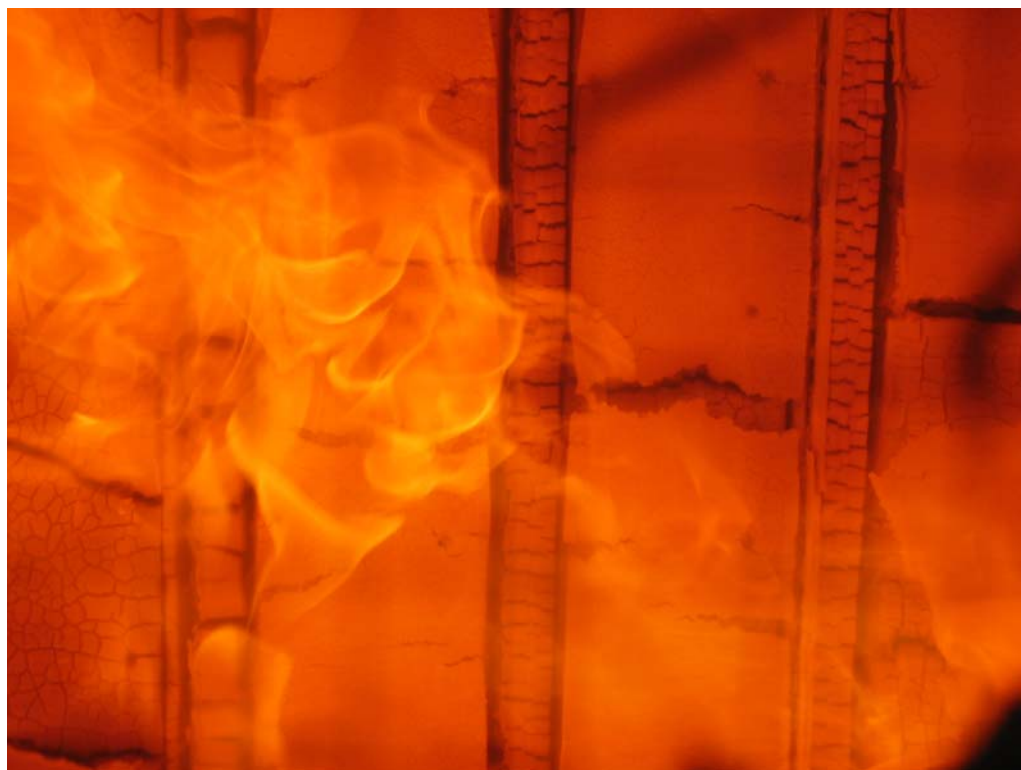
The exposed face of the construction after 90 minutes of testing

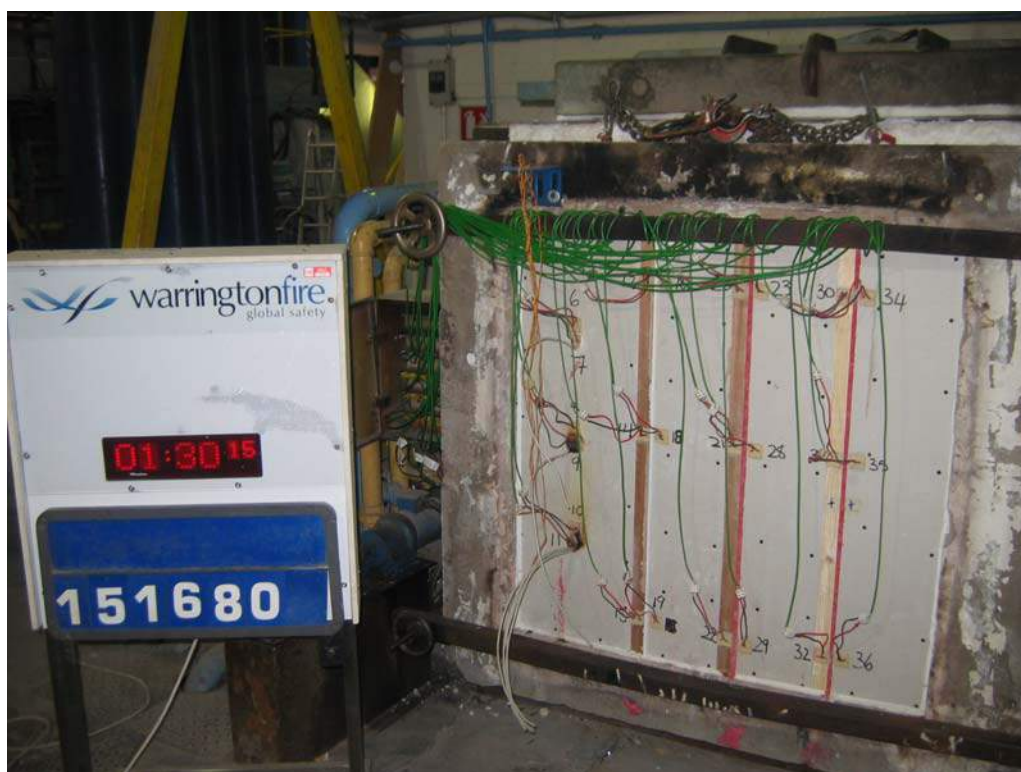
The unexposed face of the construction after 90 minutes of testing

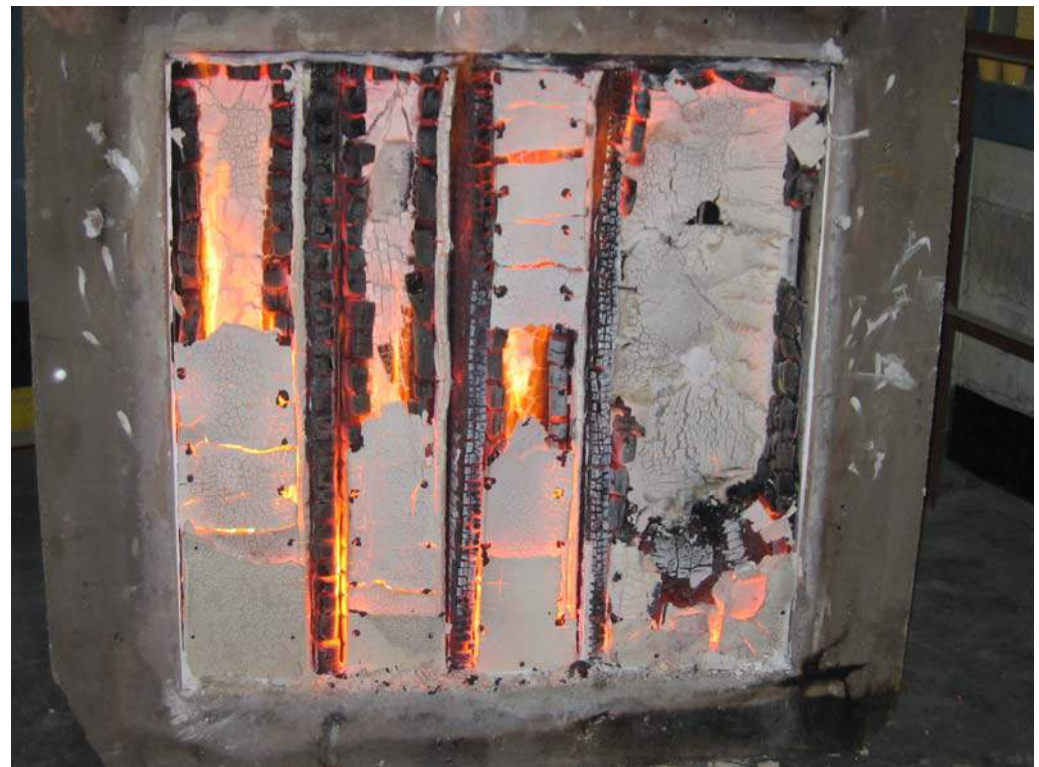
The exposed face of the construction immediately after testing

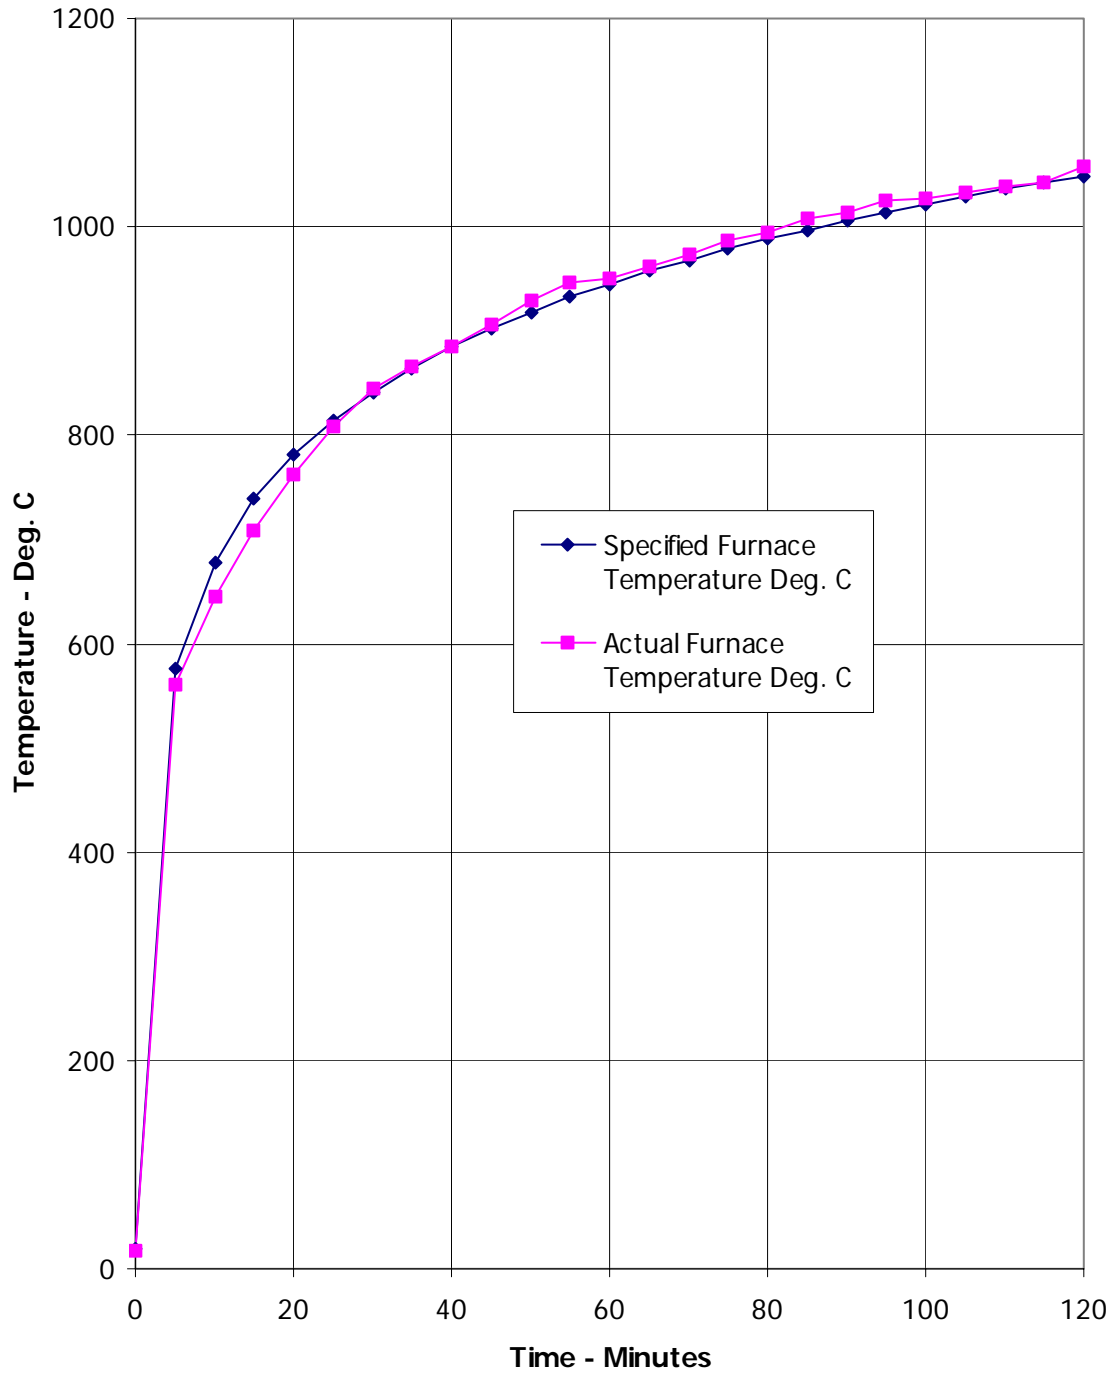
Graph Showing Mean Furnace Temperature, Together With The Temperature/Time Relationship Specified In The Standard

Time Mins	Specified Furnace Temperature Deg. C	Actual Furnace Temperature Deg. C
0	20	16
5	576	560
10	678	645
15	739	708
20	781	763
25	815	808
30	842	844
35	865	866
40	885	884
45	902	907
50	918	929
55	932	947
60	945	950
65	957	961
70	968	973
75	979	987
80	988	995
85	997	1008
90	1006	1014
95	1014	1025
100	1022	1028
105	1029	1033
110	1036	1039
115	1043	1042
120	1049	1058
